Samsung Technical Notification

To add the plastic vinyl on the surface of out box

March, 2016

Samsung Electronics Co., Ltd

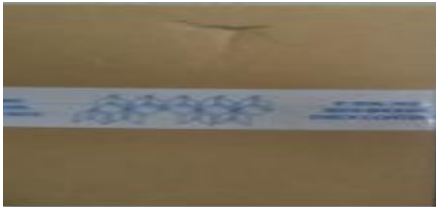
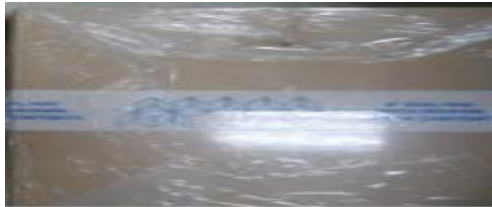
Drop Test @ 80cm height	
	Normal Box	Cover with plastic vinyl
Photo

Result	3~4cm damage	approximately 2cm damage

Samsung would like to notice to cover the plastic vinyl on the surface of out box to improve the resistance of moisture and scratch for certain rainy area.

The surface of out box cover with plastic Vinyl
